# Manhole Inspection Summary

Manhole # S37O\_\_023MH

Insp Date: **1/24/08 1:36 PM**

**Location** Address: **e churchill st**

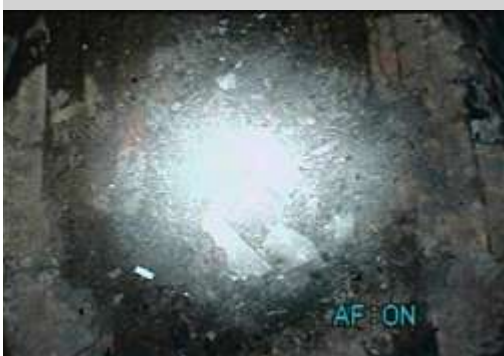
Defect 2

Condition: ☐ Sound ☐ Cracked ☐ Root Intrusion ☐ Deteriorated ☐ Leaks ☒ **Debris**

channel debris

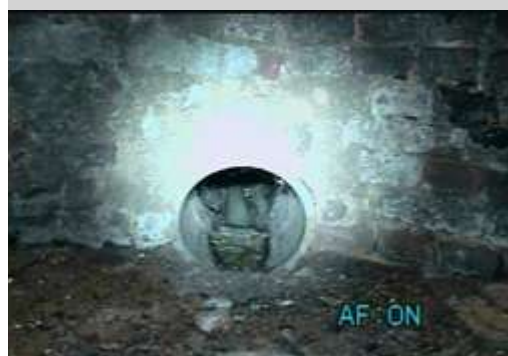
Defect 3

Condition: ☐ Sound ☐ Cracked ☐ Root Intrusion ☒ **Loose Brick** ☐ Deteriorated

Barrel loose bricks

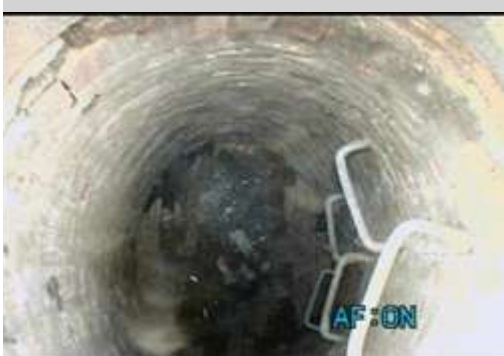
Defect 1

Offset: **2** (in.)

Condition: ☐ Sound ☐ Cracked ☐ Root Intrusion ☒ **Loose Brick** ☐ Deteriorated

offset, corbel loose bricks

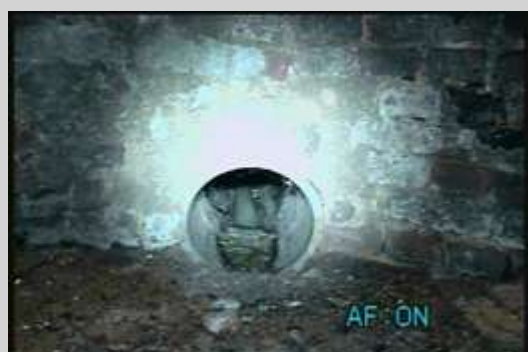
12 O'Clock Outflow

Deposits: ☐ None ☐ Mud ☐ Sludge ☒ **Debris** ☐ Grease

Silt Depth: 1 (in.) Deposits Extent: **Light**
